# Manhole Inspection Summary

Manhole # S47C\_\_044MH

Insp Date: 7/10/08 1:39 PM

**Location** Address: **Chester**

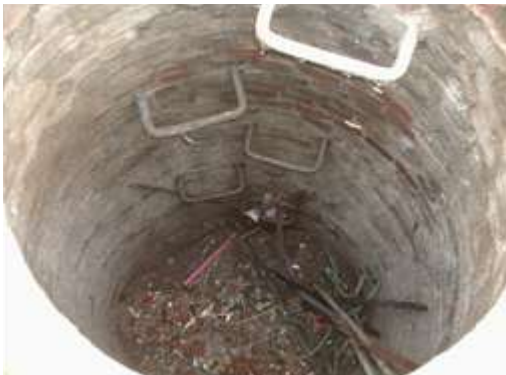
Defect 1

**Steps** Count: **5** Missing: **0** ☒ **Corroded**

corrosion

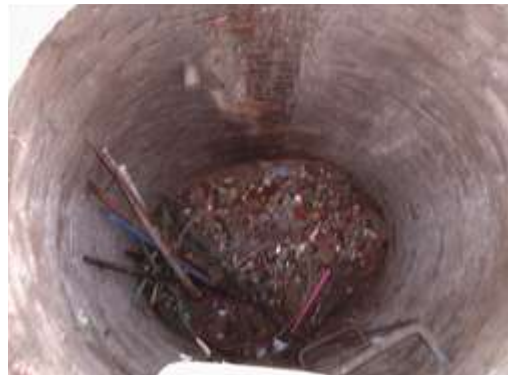
Defect 2

Infiltration: ☐ None ☒ **Joint** ☐ Cracks ☒ **Mortar** ☐ Roots ☐ Wall

infiltration

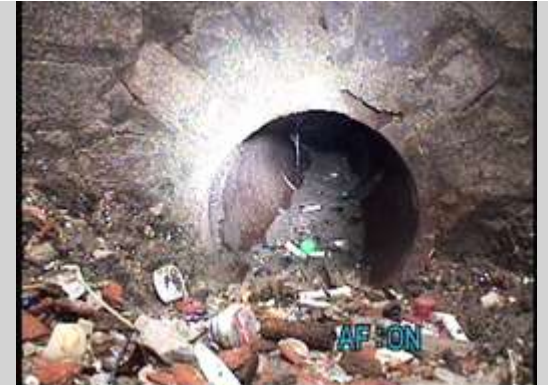
12 O'Clock Outflow

8 in. Circular Gravity Sewer  
Pipe Out @ 12 O'Clock

Infiltration: **None** Pipe Seal Cond: **Sound**
